**USE OF EXAR'S ST16C2550 WITH LINUX 2.4.X & 2.6.X OPERATING SYSTEMS,
PHOENIX BIOS VERSION 4.0 RELEASE 6.0 AND WINDOWS OPERATING SYSTEMS****1.0 INTRODUCTION**

The following information is an application consideration in regards to the use of the ST16C2550 family of devices (ST16C2450, ST16C2550 and ST16C2552) with top mark date code of "A2 YYWW". This family will be referred to as the ST16C2550 "A2" device in the remainder of this application note.

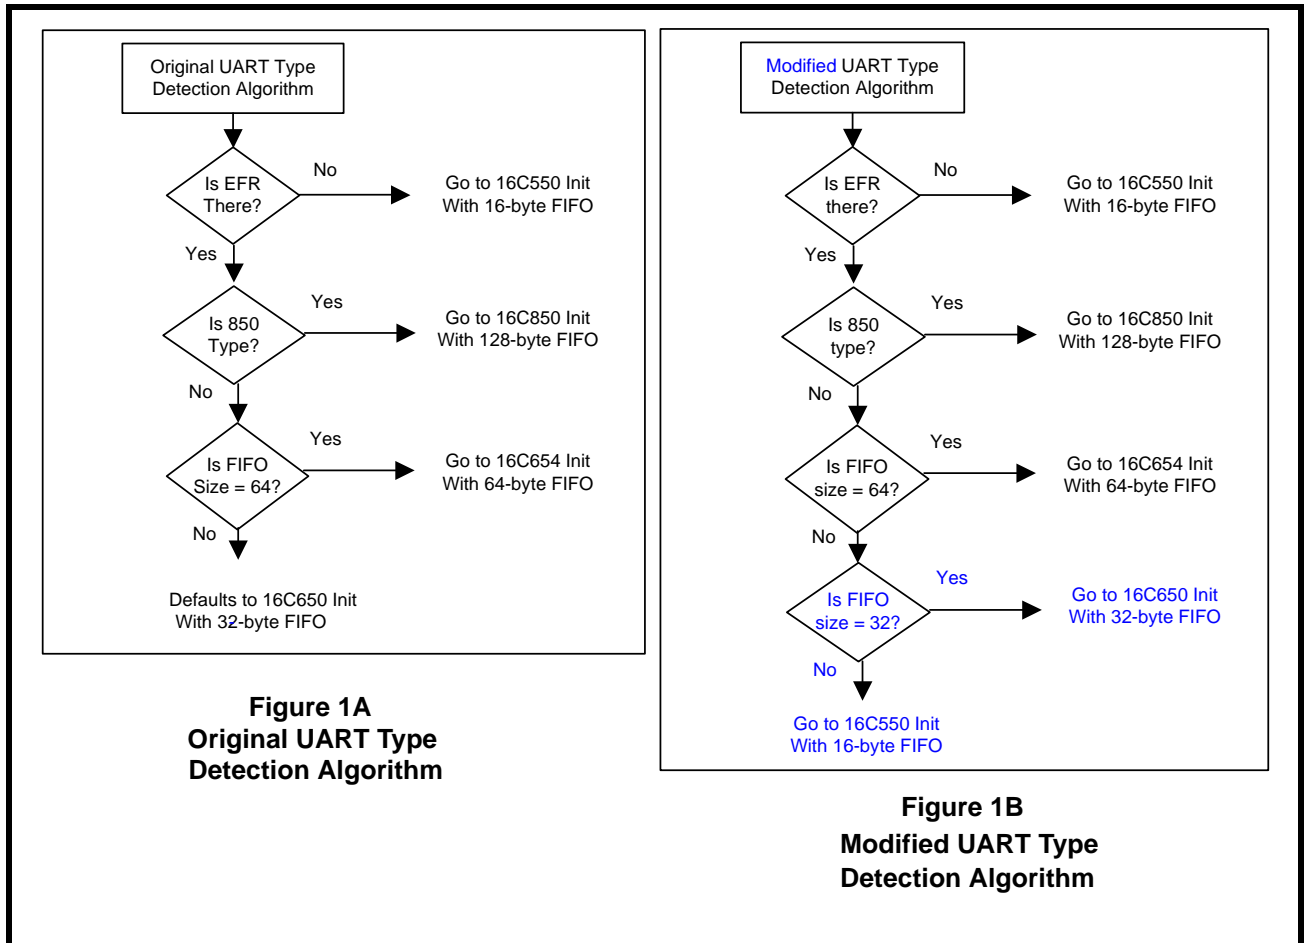
FIGURE 1. ORIGINAL AND MODIFIED UART TYPE DETECTION IN LINUX OPERATING SYSTEM KERNELS 2.4.x & 2.6.x

The Linux kernel (2.4.x and 2.6.x) identifies the ST16C2550 "A2" as a 16C650A due to the presence of the EFR register and the UART type detection algorithm. As shown in Figure 1A, the kernel defaults to the 16C650A (or 16C650V2) UART type when:

- it detects the presence of the EFR register, and
- it does not detect a 16C850 UART type or a 64-byte FIFO.

Operating the device as a 16C650V2 will cause an overrun condition resulting in data errors, due to the absence of 32-byte FIFO. This issue can be resolved if the algorithm is modified as shown in Figure 1B.

This is a software fix for the Linux 2.4.x kernel. This fix involves modifying the serial.c file and re-compiling the kernel by following the 18 steps given below. After this fix, the ST16C2550 "A2" device will be correctly identified as 16550A type. There is no need for the software patch mentioned in Solution A, which modifies the '/etc/rc.serial' file.

There is a proposed solution for Linux O/S kernel 2.6.x. as shown below. This solution involves modifying the '8250.c' file and re-compiling the kernel by following the 15 steps given below. After this fix, the ST16C2550 "A2" device will be correctly identified as 16550A type.

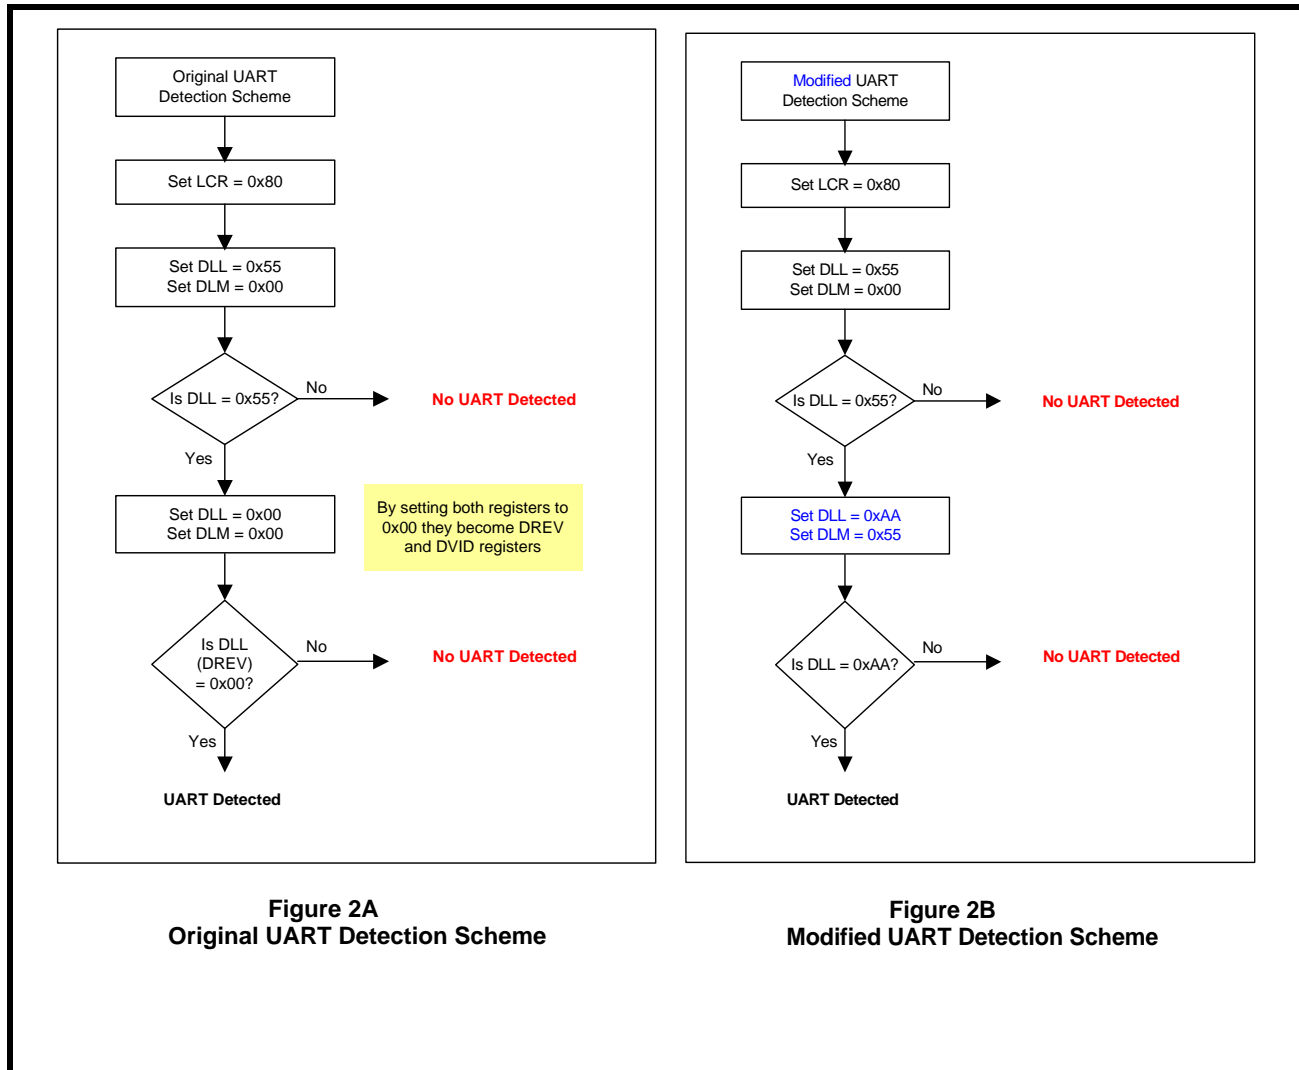
FIGURE 2. ORIGINAL AND MODIFIED UART DETECTION SCHEMES IN PHOENIX BIOS VERSION 4.0 RELEASE 6.0

The Phoenix BIOS version 4.0 release 6.0 uses a UART type detection algorithm (Figure 2A) that includes writing 0x00 to both DLL and DLM registers causing a detection error. When 0x00 is written into both DLL and DLM registers, the following read operations of DLL and DLM registers will return the value of DVID (0x02) and DREV (0x01), respectively, instead of the expected 0x00. If this algorithm is modified as shown in Figure 2B, this detection error can be eliminated. At the time of this publication, it has been observed that when a Windows O/S is used with this BIOS version, the Windows O/S performs its own detection of UARTs, thereby correcting the BIOS detection error, and the system operates properly.

This problem can be resolved by modifying the Phoenix BIOS by writing alternate values to DLL and DLM in steps 5) and 6) above. This will detect the two serial ports of the "A2" device correctly. For example, change the steps 5), 6) and 7) above as follows:

- 5) Write 0xAA to DLL;
- 6) Write 0x55 to DLM; // DLL and DLM stay as DLL and DLM
- 7) Read DLL; // Expect a value of 0xAA. Correct data validates the presence of a serial port.
// "A2 YYWW" device will pass this step correctly.
